DEPARTMENT OF TRANSPORTATION

Contract #: 04-0120F4Cty: SF/ALA Rte: 80 PM: 13.2/13.9File #: 69.28**WELDING INSPECTION REPORT****Resident Engineer:** Pursell, Gary**Address:** 333 Burma Road**City:** Oakland, CA 94607**Report No:** WIR-002662**Date Inspected:** 20-May-2008**Project Name:** SAS Superstructure**OSM Arrival Time:** 700**Prime Contractor:** American Bridge/Fluor Enterprises, a JV**OSM Departure Time:** 1700**Contractor:** Zhenhua Port Machinery Company, Ltd (ZPMC), Changxing Island **Location:** Shanghai, China**CWI Name:** Sun Wei**CWI Present:** Yes No**Inspected CWI report:** Yes No N/A**Rod Oven in Use:** Yes No N/A**Electrode to specification:** Yes No N/A**Weld Procedures Followed:** Yes No N/A**Qualified Welders:** Yes No N/A**Verified Joint Fit-up:** Yes No N/A**Approved Drawings:** Yes No N/A**Approved WPS:** Yes No N/A**Delayed / Cancelled:** Yes No N/A**Bridge No:** 34-0006**Component:** OBG**Summary of Items Observed:**

WELDING INSPECTION REPORT

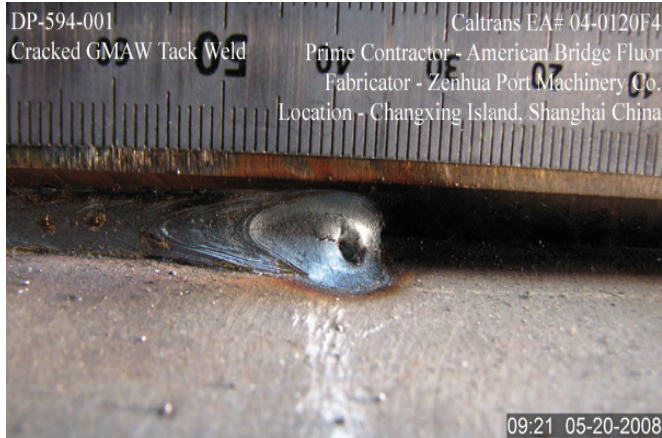
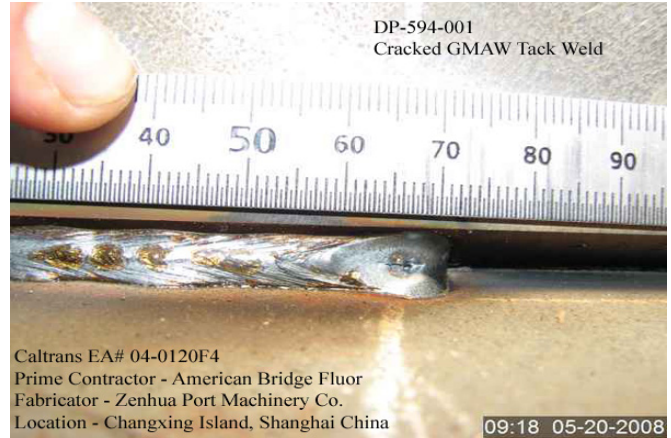
The Quality Assurance Inspector observed numerous cracked tack welds in the partial joint penetration to deck plate connection on deck panel DP-594-001. The tack welders who performed the welding were Liu Xia Qing, welder identification number 059393, and Tang Liang, welder identification number 062305. ABF representative Steve Lawton was informed by Quality Assurance Inspector David McClary. Below are digital Photographs illustrating the cracks.
